# Manhole Inspection Summary

Manhole # S15GG1015MH

Insp Date: **12/18/08 2:17 PM**

**Location** Address: **PALL MALL RD ALLEY**

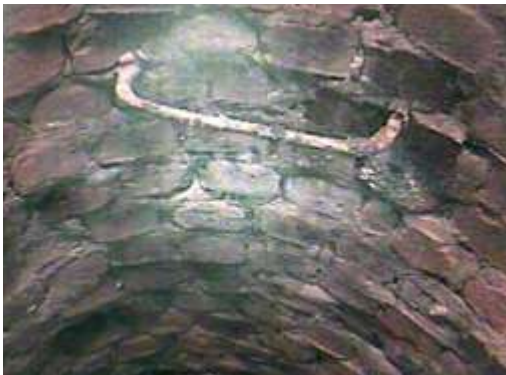
Defect 6

Condition: ☐ Sound ☐ Cracked ☐ Root Intrusion ☒ **Loose Brick** ☐ Deteriorated

LOOSE BRICKS BARREL

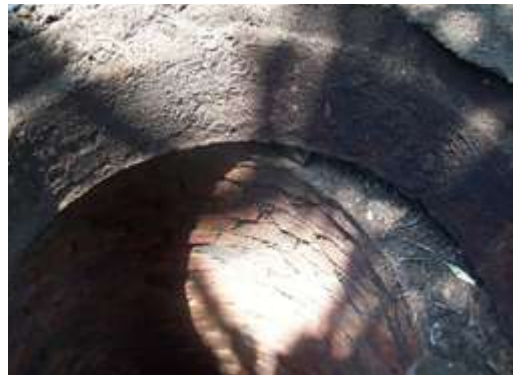
Defect 2

**Frame** Offset: **4** (in.) Condition: ☐ Sound ☒ **Cracked** ☐ Leaks

OFFSET FRAME

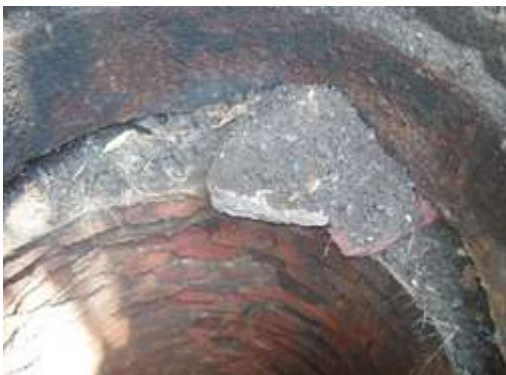
Defect 1

Condition: ☐ Sound ☐ Cracked ☐ Root Intrusion ☐ Loose Brick ☒ **Deteriorated**

DETERIORATED FRAME ADJUSTMENT

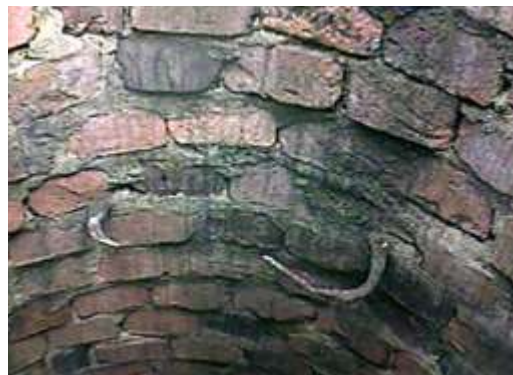
Defect 4

**Surcharge** ☒ **Evidence Of Surcharge** Depth: **2** (ft.) ☐ Active Surcharge Present

CORRODED STEP; EVIDENCE  
SURCHARGE

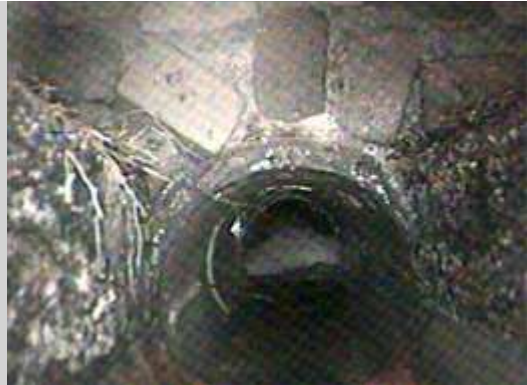
12 O'Clock Outflow

8 in. Circular Gravity Sewer  
Pipe Out @ 12 O'Clock

Pipe Height: (in.) Direct  
Pipe Material: **Clay** ☐ Pipe Lined  
Invert Depth: **14.74** (ft.) Flow Characteristics: **Slow**  
Deposits: ☒ None ☐ Mud ☐ Sludge ☐ Debris ☐ Grease  
Silt Depth: (in.) Deposits Extent:  
Infiltration: **None** Pipe Seal Cond: **Sound**

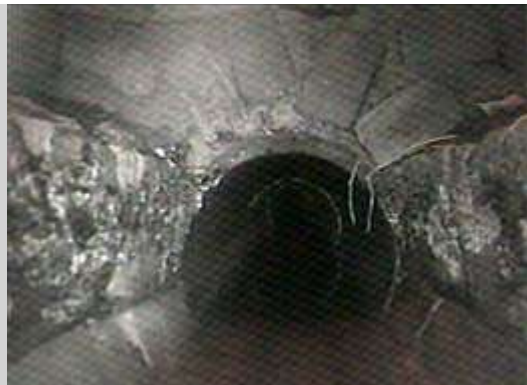
6 O'Clock Inflow

8 in. Circular Gravity Sewer  
Pipe In @ 6 O'Clock

Pipe Height: (in.) Direct  
Pipe Material: **Clay** ☐ Pipe Lined  
Invert Depth: **14.68** (ft.) Flow Characteristics: **Slow**  
Deposits: ☒ None ☐ Mud ☐ Sludge ☐ Debris ☐ Grease  
Silt Depth: (in.) Deposits Extent:  
Infiltration: **None** Pipe Seal Cond: **Sound**
